AERIAL PHOTOGRAPHIC ANALYSIS INDUSTRIAL ENTERPRISES SITE Rosedale, Maryland

EPA Region 3

**AERIAL PHOTOGRAPHIC ANALYSIS
INDUSTRIAL ENTERPRISES SITE**

Rosedale, Maryland

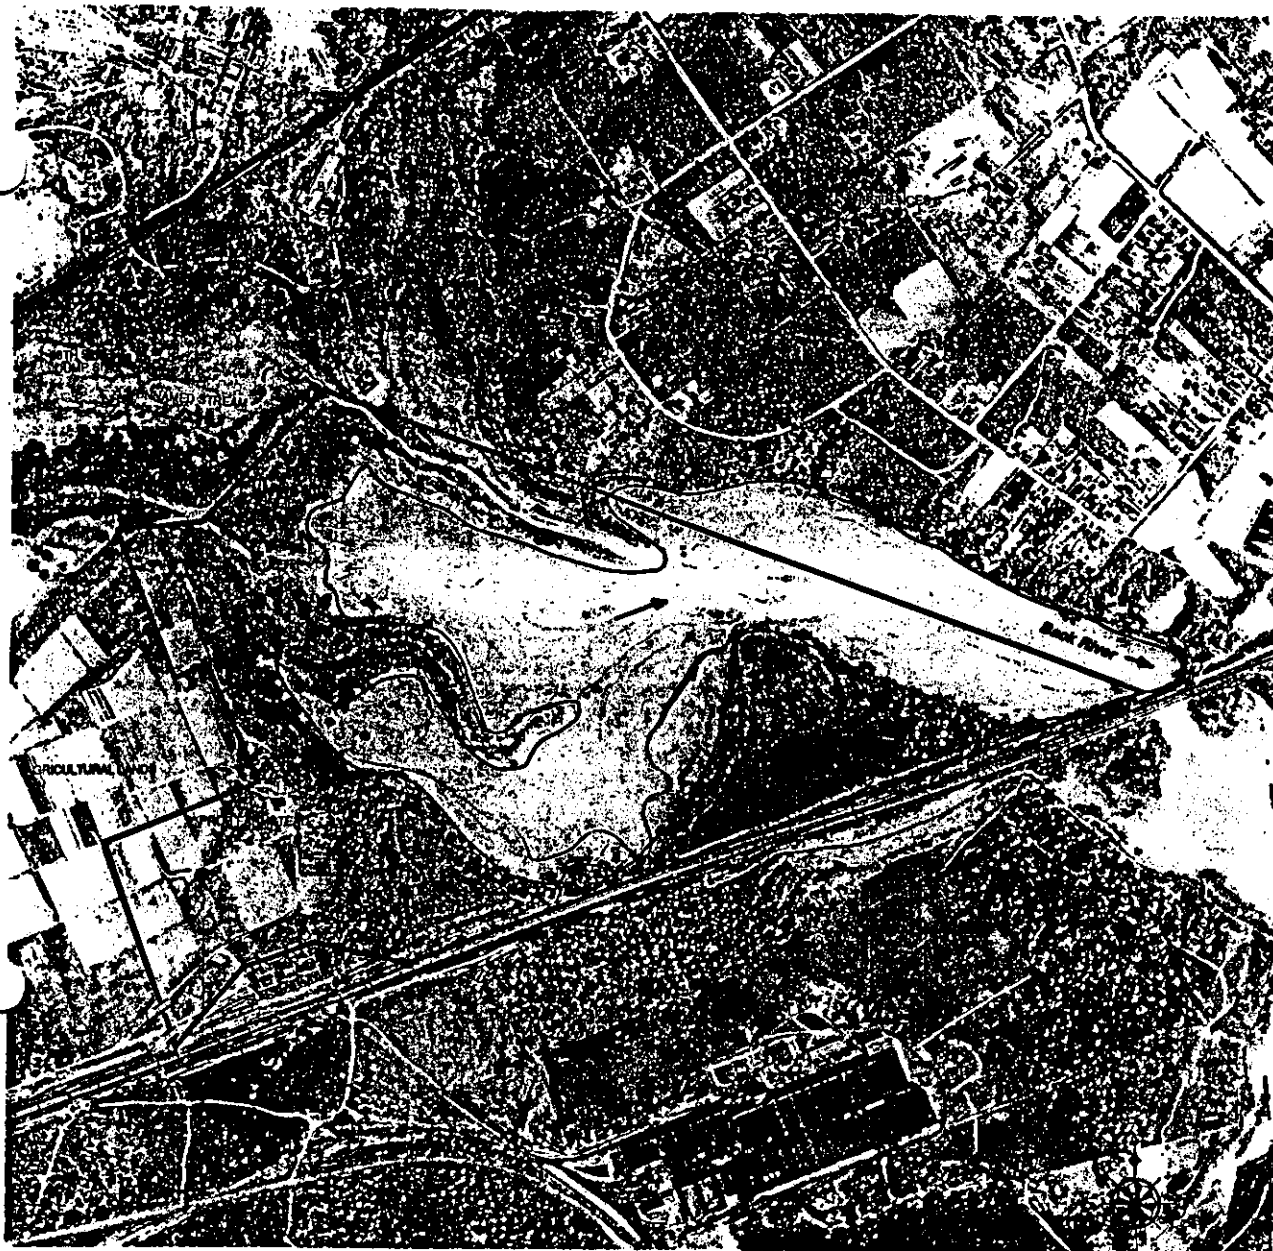
Figure 3. Industrial Enterprises site, April 23, 1938. Approximate scale 1:6,630.

APRIL 23, 1938 (FIGURE 3)

Initial coverage of the Industrial Enterprises site shows a marshland prior to development. The central and eastern portions of the site are predominately occupied by a floodplain of the Back River. The eastern side of this floodplain extends beyond the eastern site boundary. The western side of this floodplain merges with a relatively flat and muddy shoreline of the marshland. The shoreline is at the toe of a western slope with a relatively-flat top. Agricultural lands extend from the head of this slope to beyond the western site boundary. In the southwestern portion of the site, an access road (A1) leads from the western site boundary to a probable farmstead situated between two gullies. A network of roads on the northern side of this farmstead connects between the farmstead and the western site boundary. East of access road A1, two flat-topped elevated areas are identified as Hill-1 and Hill-2 for the purposes of this analysis. Segments of another access road (A2) are visible south of access road A1 and along the southern sides of both Hill-1 and Hill-2.

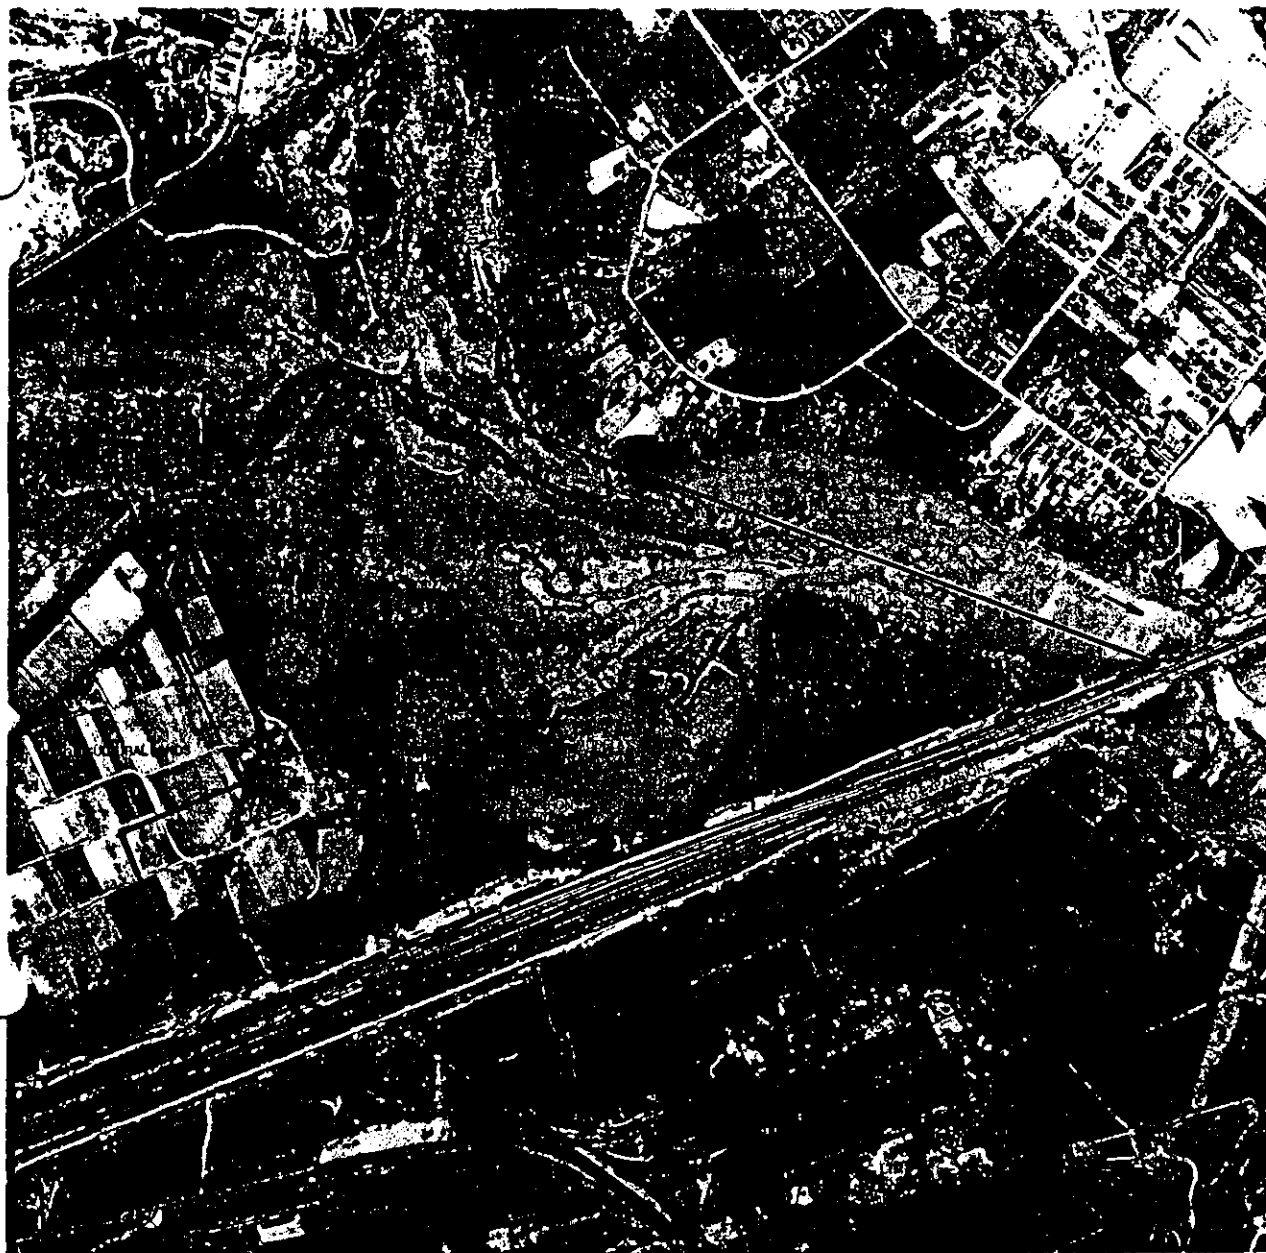
Figure 4. Industrial Enterprises site, April 25, 1943. Approximate scale 1:6,530.

APRIL 25, 1943 (FIGURE 4)

The farmstead observed in 1938 appears relatively unchanged. Probable road construction activity along access road A2 is visible at the southern sides of both Hill-1 and Hill-2. At Hill-1, a trail (Trail-1) extends northward to a ground scar (GS-1) located on the edge of this hill. Mud flats and vegetation (VEG) are visible in the central and eastern portions of the site.

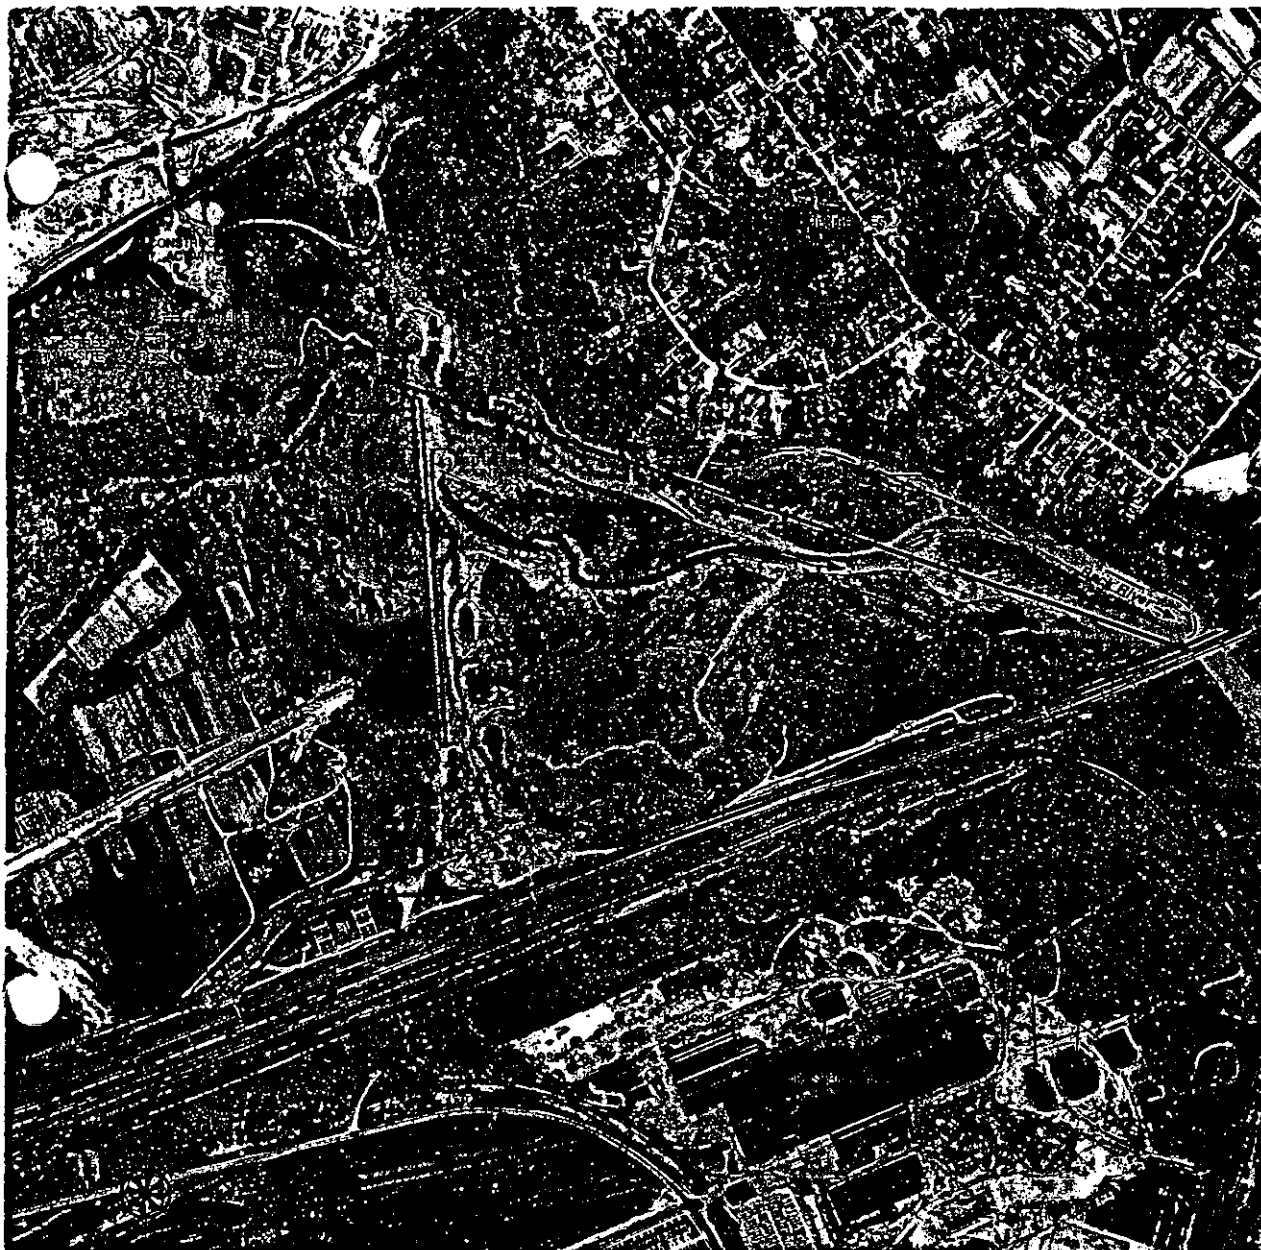
Figure 6. Industrial Enterprises site, September 25, 1957. Approximate scale 1:6,700.

SEPTEMBER 25, 1957 (FIGURE 6)

The approximate location of the floodplain initially identified and delineated on the 1938 photograph (Figure 3) is represented by dashed lines on this photograph.

Along the western site boundary, construction of Quad Avenue* has bisected the farmstead property and it is possible that the level of activity of the agricultural and livestock operations at the farmstead has been reduced. Since 1953 deposition and manipulation of fill materials has occurred on Hill-1 and on the portion of the floodplain that was located between the northern side of Hill-1 and the northeastern site boundary. These fill materials include light-toned probable fill (FL) and possible solid waste material (SW). North of Hill-1, a row of evenly-spaced pylons demarcates the pre-existing marshland to the west and the newly filled portion of the floodplain to the east. Hill-1 now appears to be a staging area for probable landfilling operations onsite and includes the following features: lagoon (LG-1) containing dark-toned standing liquid, irregularly shaped mounds of possible solid waste, a ground surface primarily comprised of stained (ST) and disturbed ground, an accumulation of probable storage containers (lack of photographic resolution precludes positive identification of drums), numerous dump truck vehicles, and expansion (not annotated) of access road A2. North of Hill-1 and west of the row of pylons, the flow of water from the marshland has ponded (annotated as Probable Pond), probably as a result of the blockage formed by the deposition of fill material. East of the row of pylons, the following features are observed: a new access road (A3), numerous rectangular containers, an extensive mound of probable fill material with a stain on its northern side, and two lagoons (LG-2 and LG-3) containing dark-toned standing liquid (DTSL).

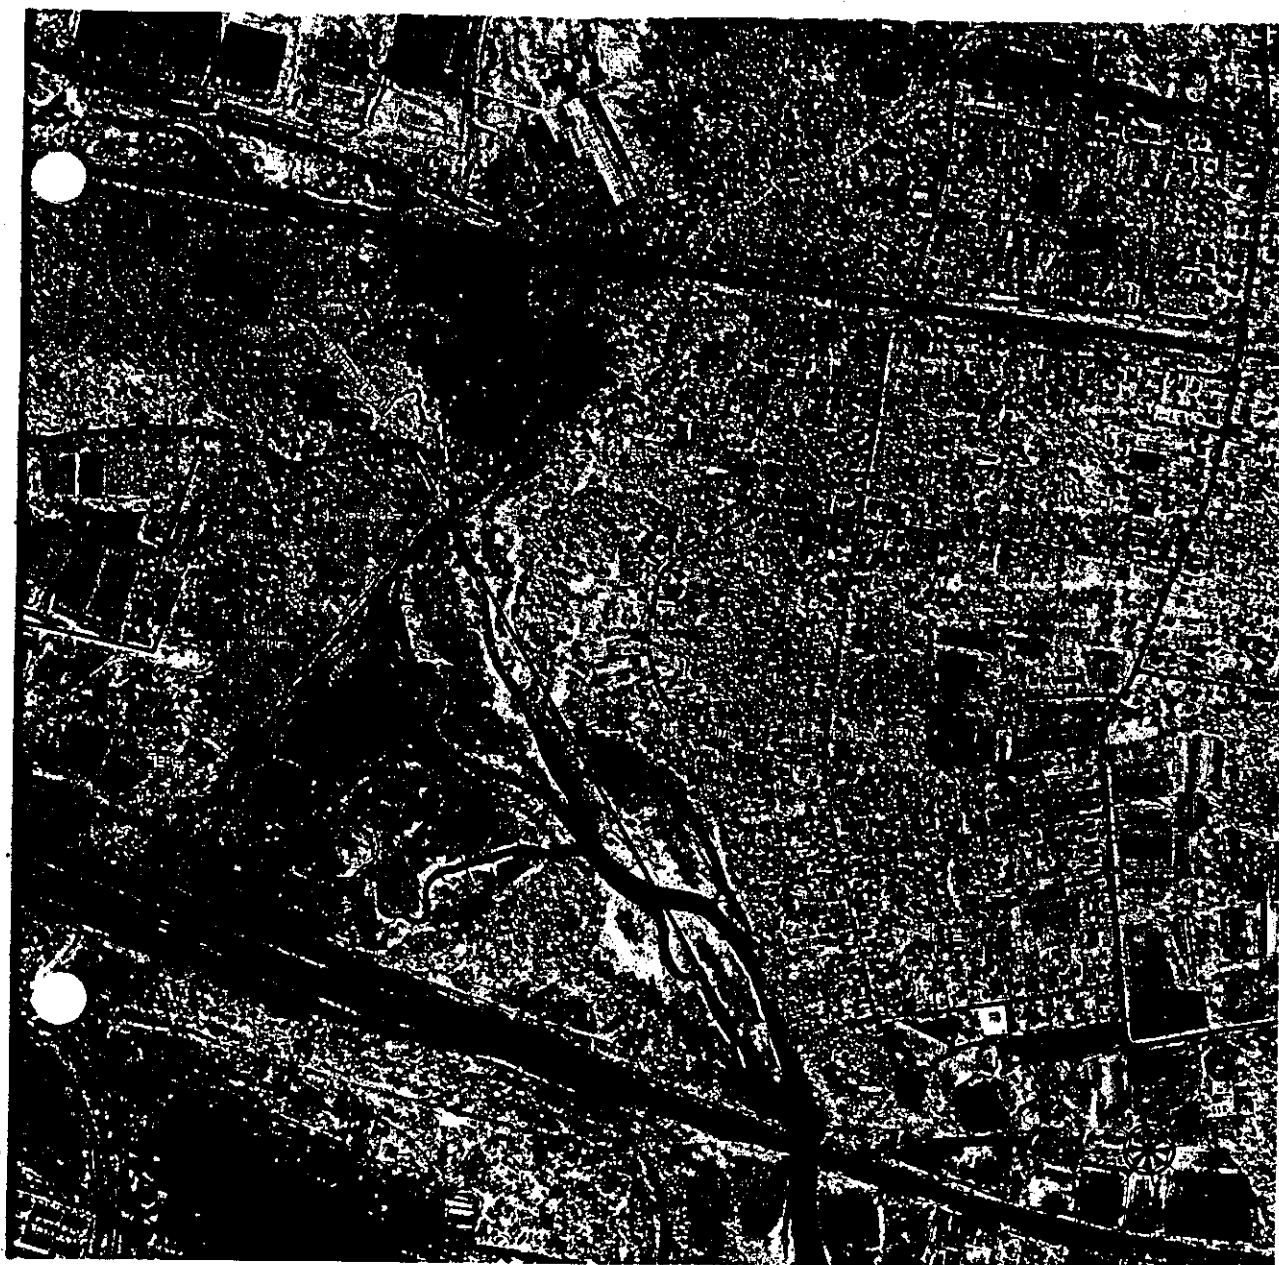
Figure 7. Industrial Enterprises site, August 2, 1960. Approximate scale 1:7,440.

AUGUST 2, 1960 (FIGURE 7)

The southwestern portion of the site is located near the edge of both film transparencies of the stereo pair, and was partially viewed monoscopically. This portion of the site appears relatively unchanged since 1957. Due to the location of the site near the edge of the film transparency selected for enlargement, the southwestern corner of this portion of the site was omitted.

The farmstead property appears relatively unchanged since 1957. The row of pylons observed in 1957 now supports a sewer pipe*. Both ends of this sewer pipe remain buried, so an outfall point is not discernible. The previously discrete Hill-1 has merged with a new fill area (FA-1), which is filled with medium-toned material. Since 1957, the extent and contents of lagoon LG-1 have increased to the south, where the material comprising the irregularly shaped mound of probable solid waste observed in 1957 now appears to be scattered. The ground surface remains primarily comprised of stains, graded fill, disturbed ground, and accumulations of probable solid waste, which exhibit a mottled surface appearance. Lack of photographic resolution precludes the identification of the probable storage containers observed in 1957. Near the southern site boundary, numerous vehicles remain discernible on and around access road A2. To the north and west of the sewer pipe, revegetation obscures the probable pond observed in 1957. East of the sewer pipe, the two lagoons (LG-2 and LG-3) continue to contain dark-toned standing liquid and a fourth lagoon (LG-4) containing dark-toned standing liquid has been installed. Although these lagoons are not readily discernible on the print, resolution of their locations was possible through stereoscopic analysis of the photo transparencies. Access road A3 has been extended past the northeastern site boundary, where a culvert bridge is now present. This bridge provides access to the eastern portion of the adjacent 68th Street Dump site, where a new incinerator stack has been installed and probable waste disposal containers are noted. A ground scar is visible at the previous location of probable construction activity.

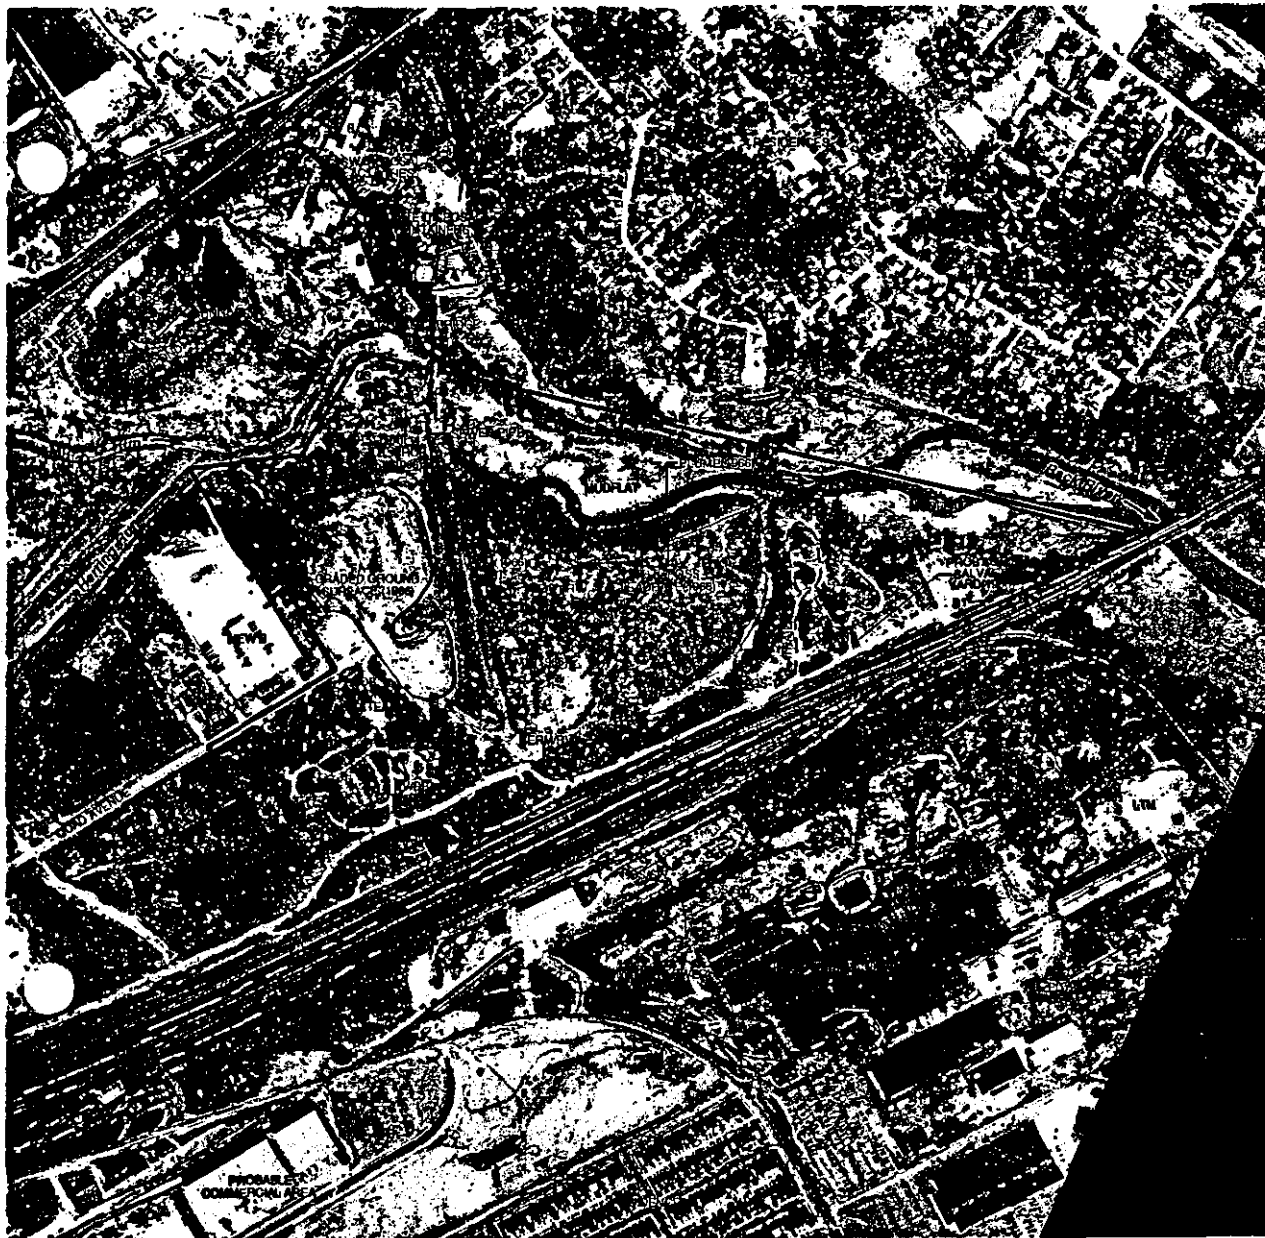
Figure 10. Industrial Enterprises site, October 1968. Approximate scale 1:7,200.

OCTOBER 1968 (FIGURE 10)

The farmstead, now identified as probably abandoned, and a portion of Trail-3 remain visible since 1966. South of the probable abandoned farmstead, the previous locations of vehicles, debris, and solid waste are obscured by revegetation.

Within the northern site boundary, the dark-toned probable fill material observed in 1966 is now identified as a trail (Trail-4), which leads westward to an area with ground scarring and staining. To the south, on the marshland observed in 1966, a graded fill area (FA-2) has been established. At the eastern end of Quad Avenue, the vehicles observed in 1966 have been removed. The surface of fill area FA-1 and the berm appear to be revegetating. The location of the plume previously discerned along the northeastern base of this fill area is not readily discernible. The addition of fill material to the southern side of FA-1 since 1966 is noted. Further south, the graded ground surface visible since 1964 has revegetated. At Hill-2, most of the contents of the probable auto salvage yard evident in 1966 have been removed. Trail-2 has expanded into a road network and ground scar GS-1 remains visible.

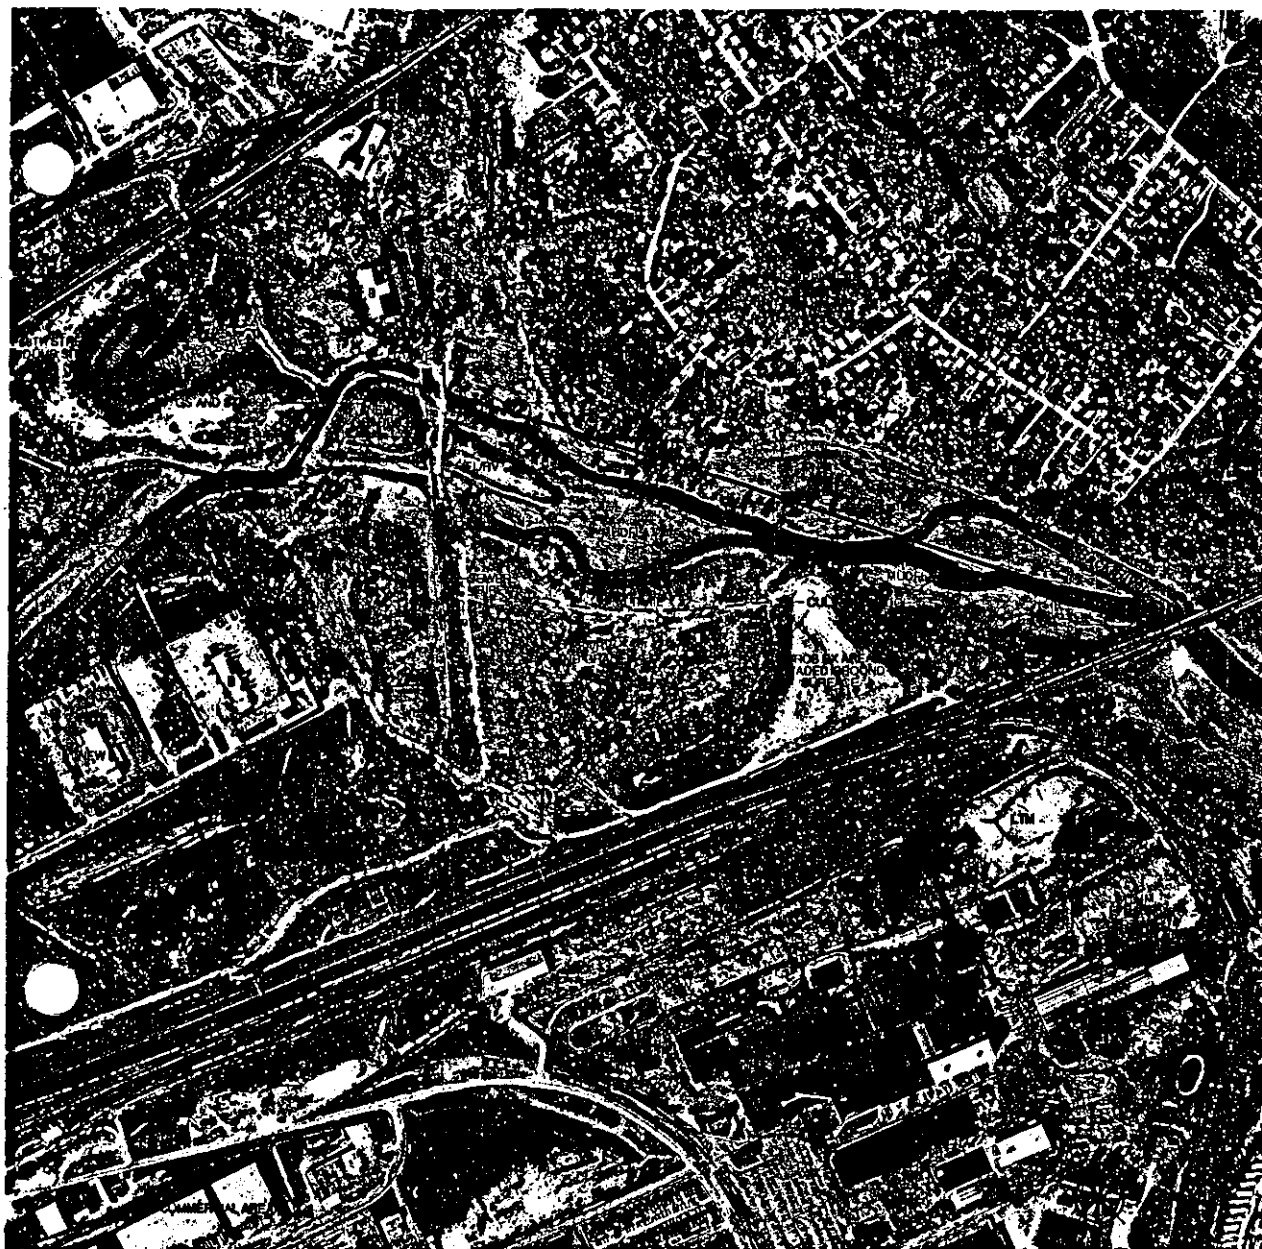
Figure 11. Industrial Enterprises site, November 5, 1971. Approximate scale 1:7,000.

NOVEMBER 5, 1971 (FIGURE 11)

Within the northern site boundary, a new fill area (FA-3) obscures the former locations of Trail-4, the area with ground scarring and staining observed in 1968, and a portion of the sewer pipe. To the south, a new excavation area is present along the southern side of FA-2. Since 1968 the addition of fill material along the southern side of FA-1 and a new culvert bridge at the easternmost side of FA-1 are noted. Trails are noted on the surface of fill area FA-1. The surfaces of the three fill areas (FA-1, FA-2, and FA-3) exhibit grading and revegetation. At Hill-2, the top is now identified as a probable extraction area with a graded ground surface. It is possible that the topsoil from Hill-2 has been used on the three fill areas in the site. North of building B1, disturbed ground and unidentified objects are present.

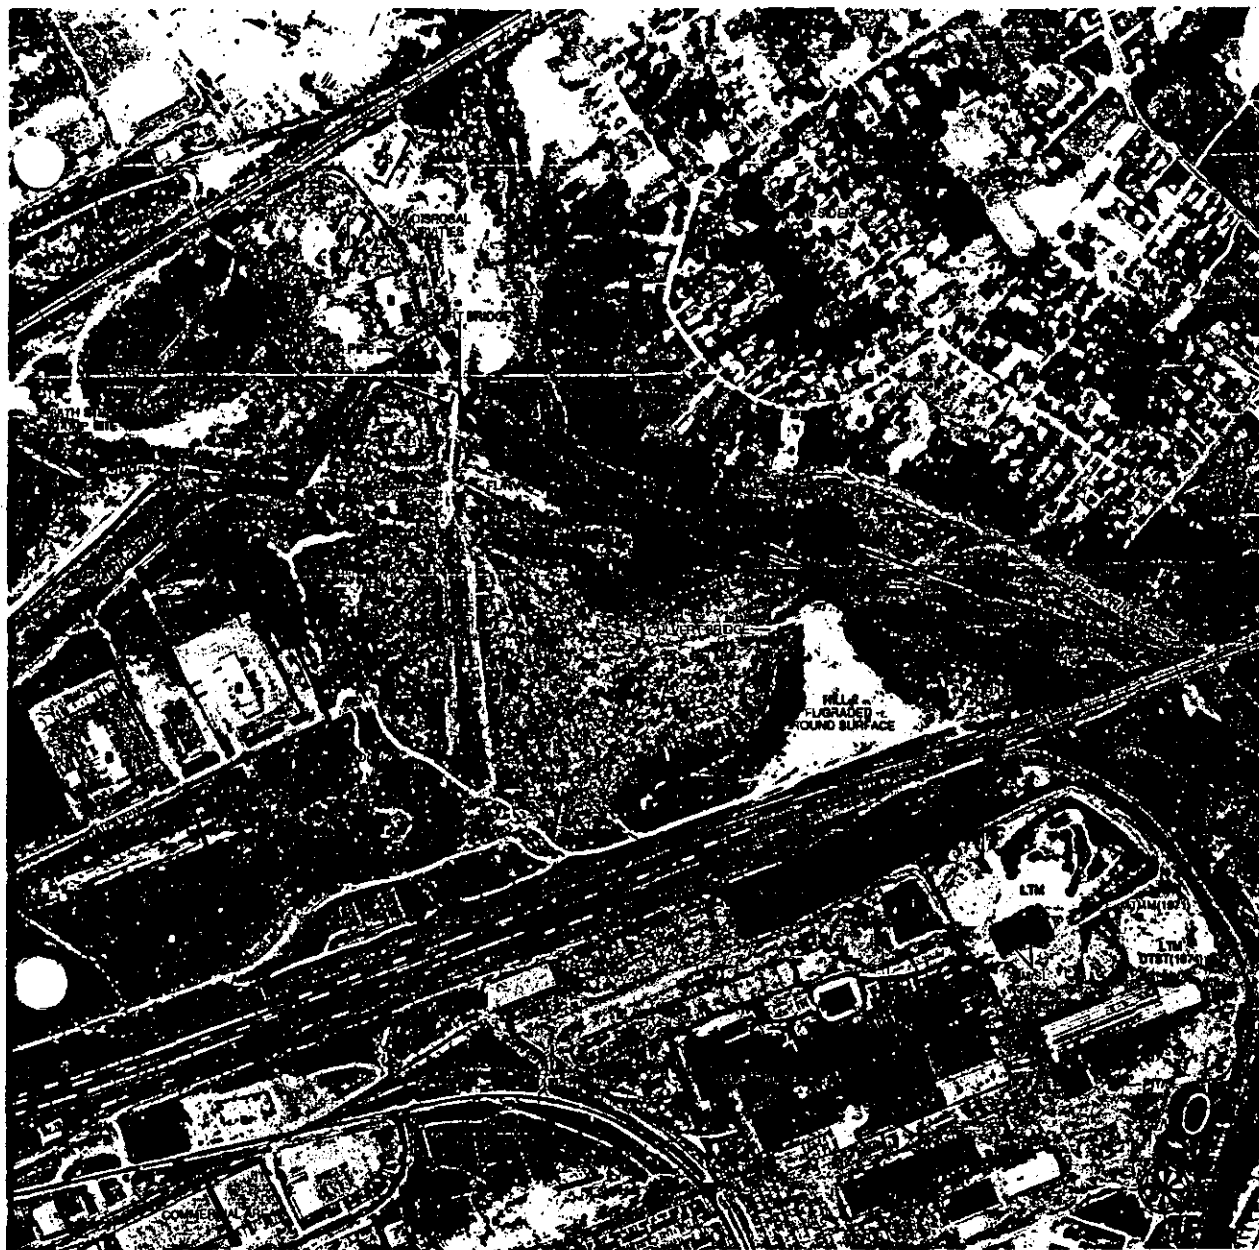
Figure 12. Industrial Enterprises site, June 14, 1973. Approximate scale 1:7,000.

JUNE 14, 1973 (FIGURE 12)

At Hill-2, building B1 has been removed. At the eastern end of Quad Avenue, delineation of the northern face of the embankment is noted. The remainder of the site appears relatively unchanged since 1971.

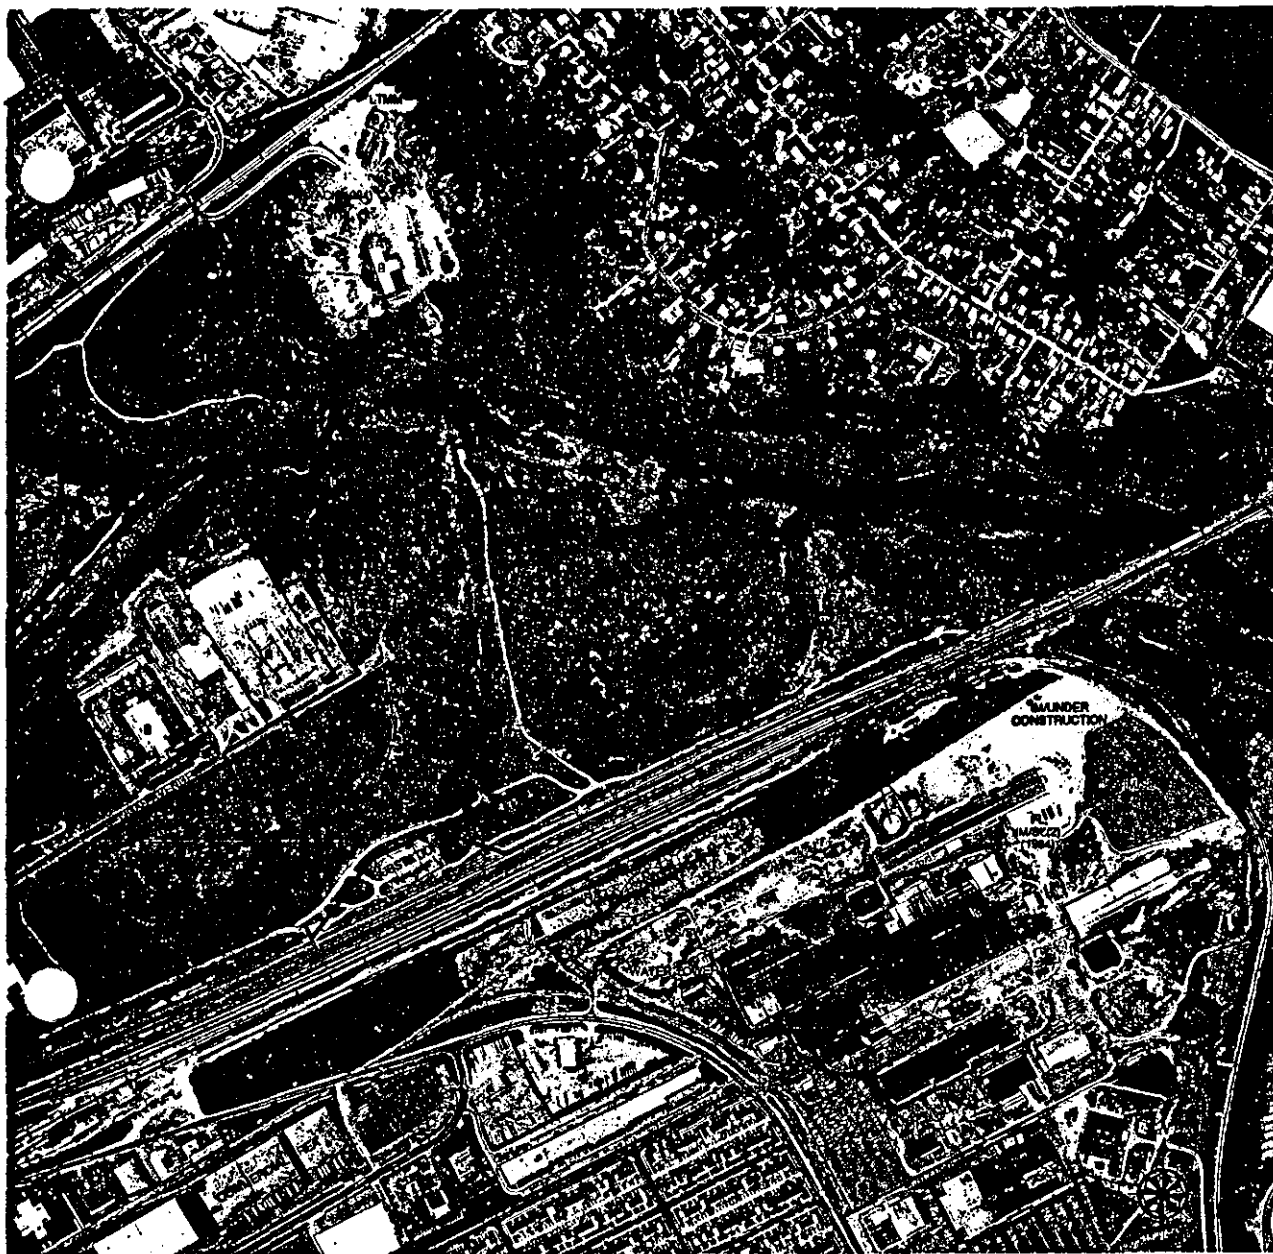
Figure 14. Industrial Enterprises site, May 21, 1992. Approximate scale 1:7,310.

MAY 21, 1992 (FIGURE 14)

Revegetation of the site partially obscures the following features observed in 1984: the sewer pipe the northern side of the ditch the excavation area located along the southern side of fill area FA-2, and the eastern side of access road A1, where debris was observed in 1984. From the southwest corner of the site, a segment of access road A1 continues to extend northward to a new earthen pad. At this pad, probable fill material occupies both the gap and the southern side of the ditch observed in 1984. Near the southern end of access road A3, three areas containing debris are noted. Near the southeastern corner of Hill-2, revegetation obscures an area previously observed with ground scarring.

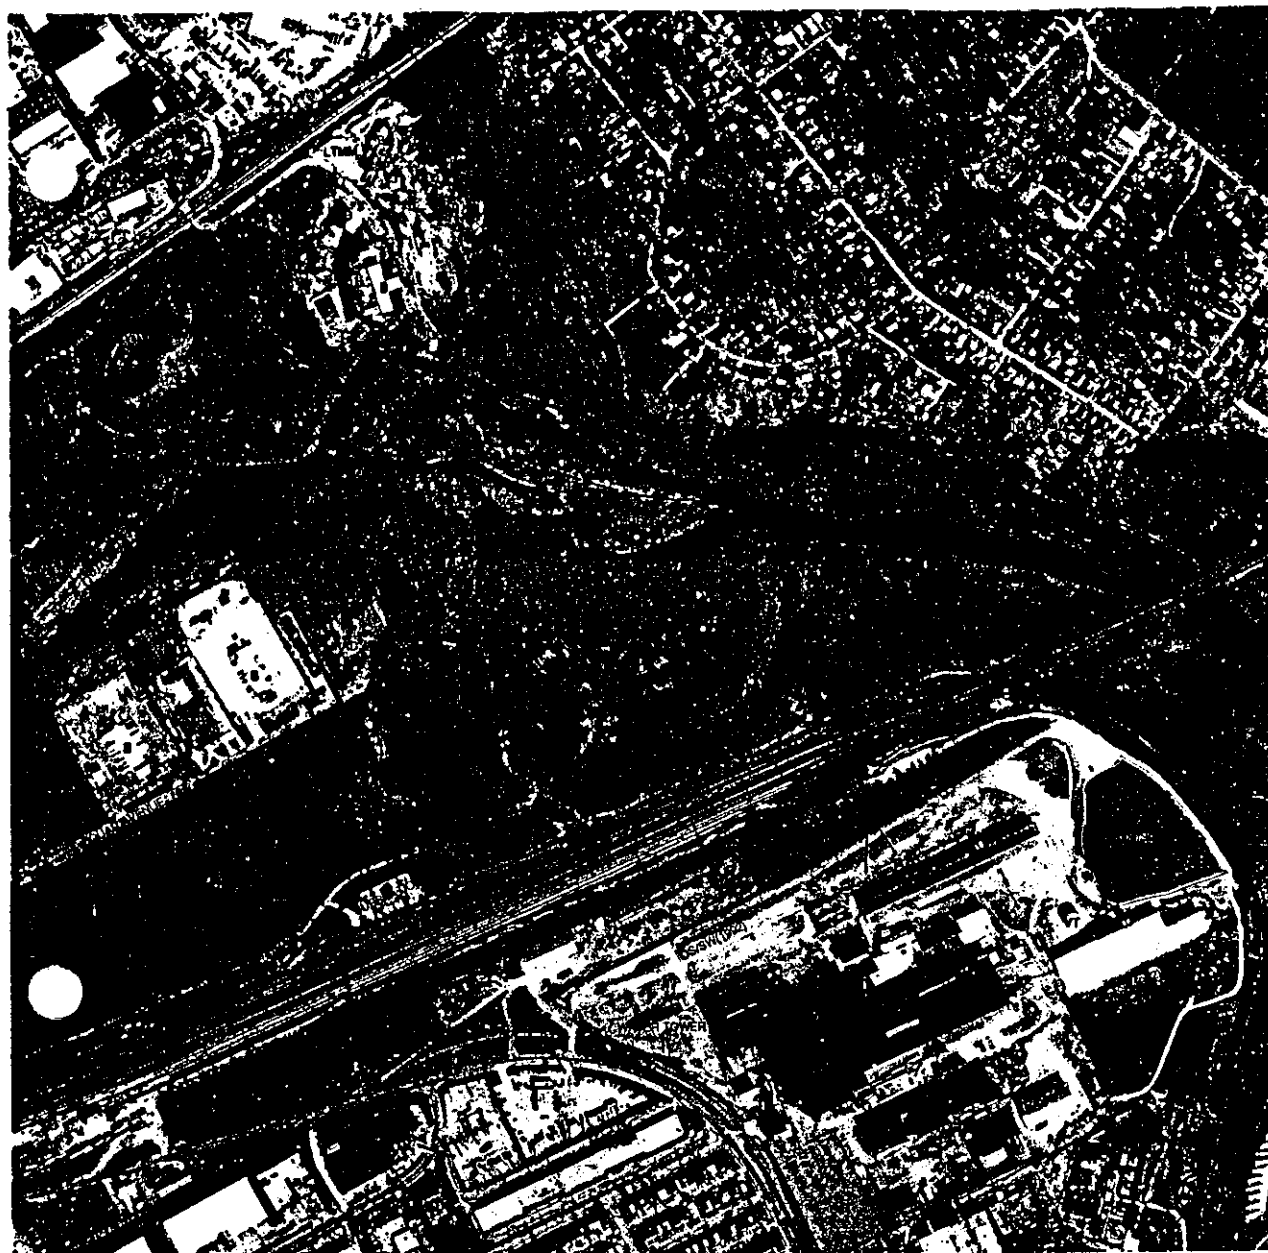
Figure 15. Industrial Enterprises site, February 9, 1998. Approximate scale 1:7,110.

FEBRUARY 9, 1998 (FIGURE 15)

The approximate location of the floodplain initially identified and delineated on the 1938 photograph (Figure 3) is represented by dashed lines on this photograph. The site appears inactive, with no environmentally significant developments since 1992.
